# NOTICE TO MARINERS

**No. 349(T) OF 2021**

**PORT OF MALLACOOTA INLET - BASTION POINT BOAT RAMP**

**APPROACH CHANNEL – ROCKS DISLODGED FROM SEA WALL**

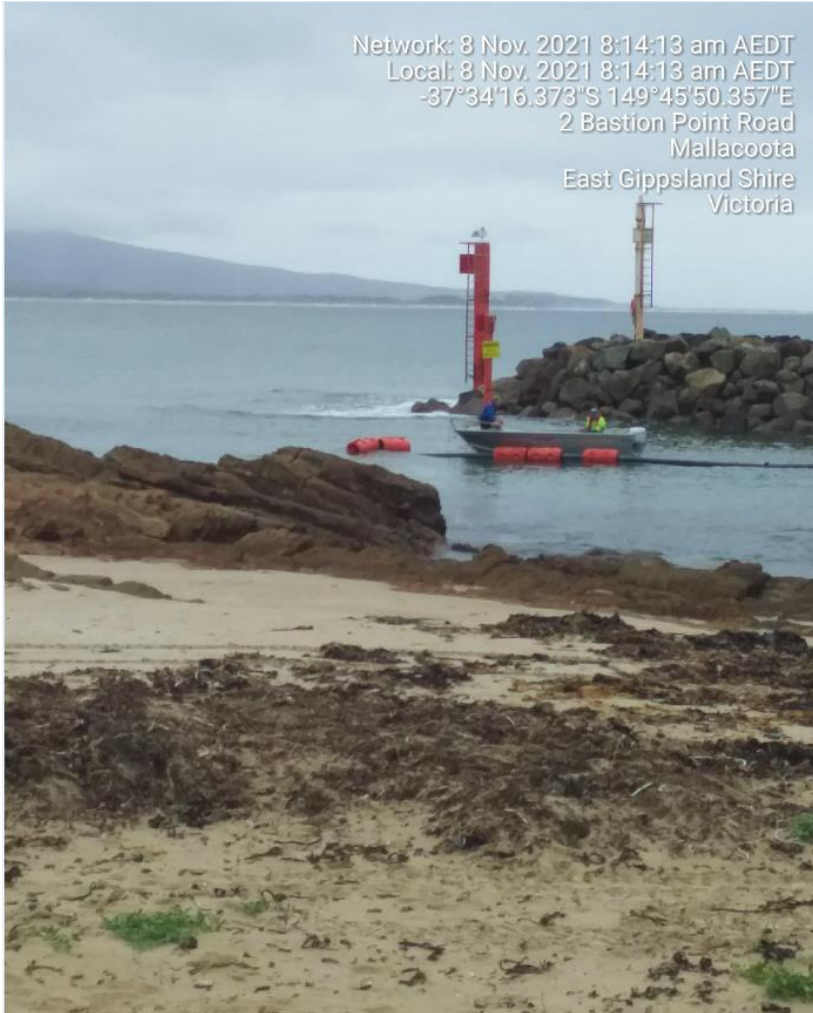
East Gippsland Shire has reported that the rock has split into 3 pieces located near the seawall midway between Bastion Point port hand lateral beacons #2 & #4. The rocks are compromising the available depth in that position. The rocks are located in a surf zone and are unable to be marked. East Gippsland Shire will remove the rocks as soon as is practically possible.

Mariners are advised to take extra precaution and avoid entering or departing the boat ramp approach entrance close to the seawall. A photograph and map indicating the position of the rock is attached to this Notice.
